## NATIONAL ADVISORY COMMITTEE FOR AERONAUTICS

### TECHNICAL NOTE

No. 959

AXIAL FATIGUE TESTS OF 10 AIRPLANE WING-BEAM SPECIMENS

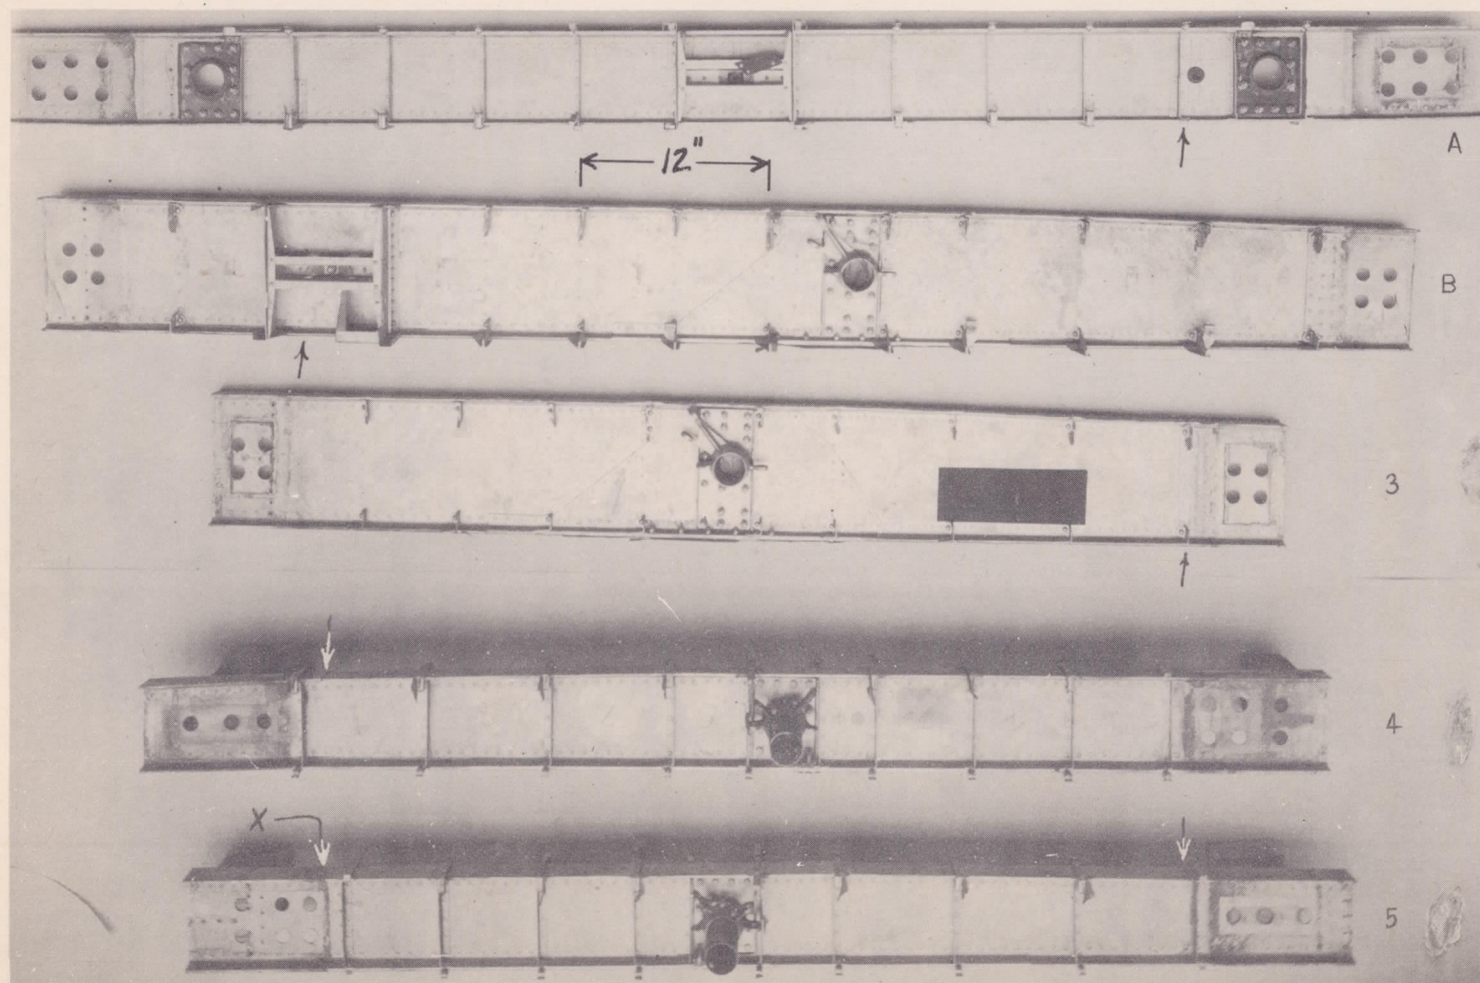
It will be noted that 8 of the 10 wing-beam specimens failed near one end, and that of the 9 specimens containing a web splice 8 failed at the splice and the flange of the ninth was practically at the point of failure at the time that the principal failure occurred elsewhere. Although the minimum cross-sectional area occurred at one end, the taper is judged to be so slight, at least over an appreciable length at the small end, as to be insignificant. The splice, however, may produce an important local stress concentration. The splice is undoubtedly less rigid than the solid flanges which are in parallel with it; hence the load which is carried by the web at a location remote from the splice must be transferred to the flanges by the rivets joining the flanges to the web near the splice. Thus these rivets become active rivets. It is difficult to estimate the distribution of load among the rivets and the stress concentration factor at such rivets. In general, the few available results of fatigue tests on riveted joints where the rivets are active indicate a much higher value of  $k_f$  than for idle rivets or empty holes. Thus the splice may cause a notch effect by the transfer of load from the web to the flanges and by the fact that a high stress concentration may occur at the rivets which transfer this load.

Figure 1.- Specimens A, B, 3, 4, and 5 after failure. The extent to which the specimens were imbedded in the terminal fixture is shown by the discolored area at the ends. Arrows indicate the principal failure.

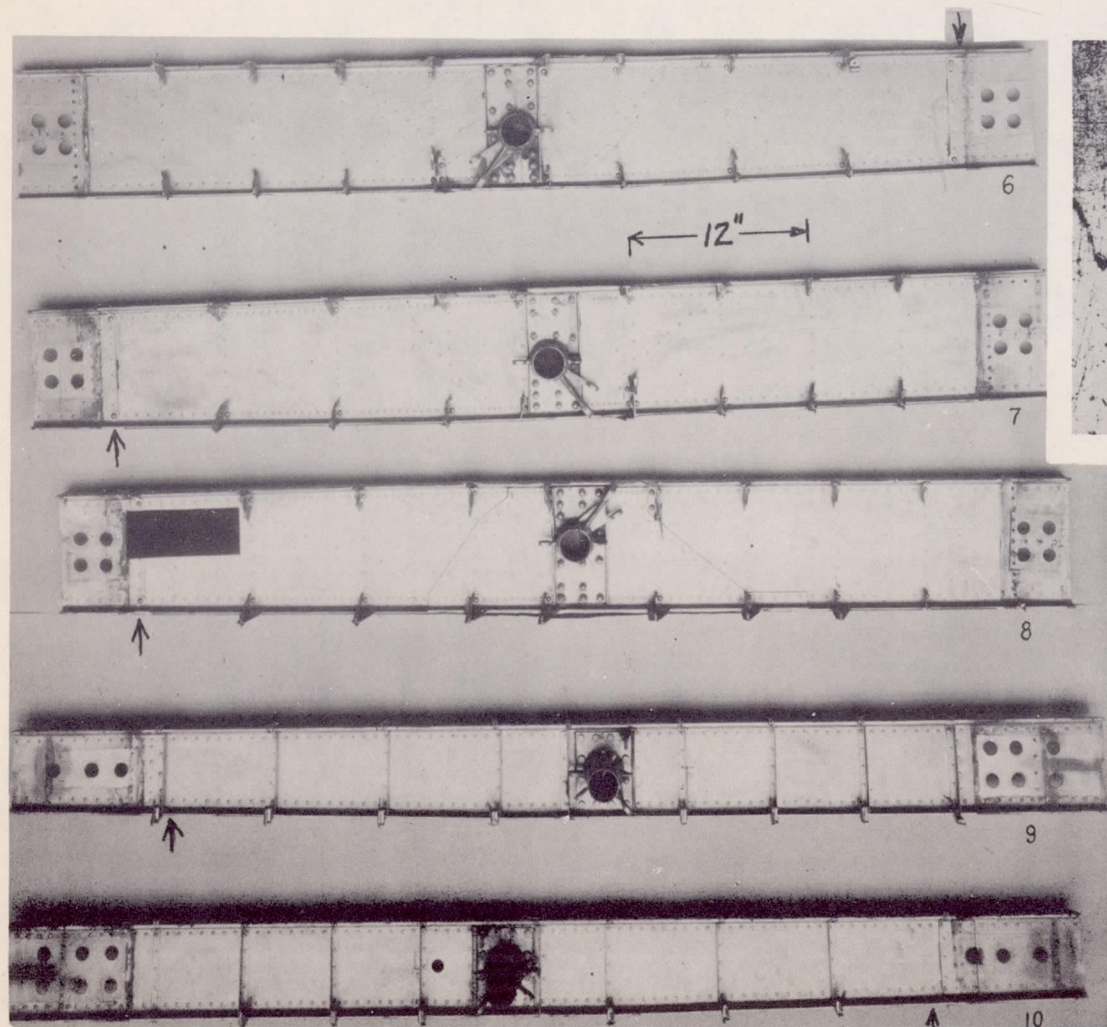
Figure 2.- Specimens 6 to 10 after failure.

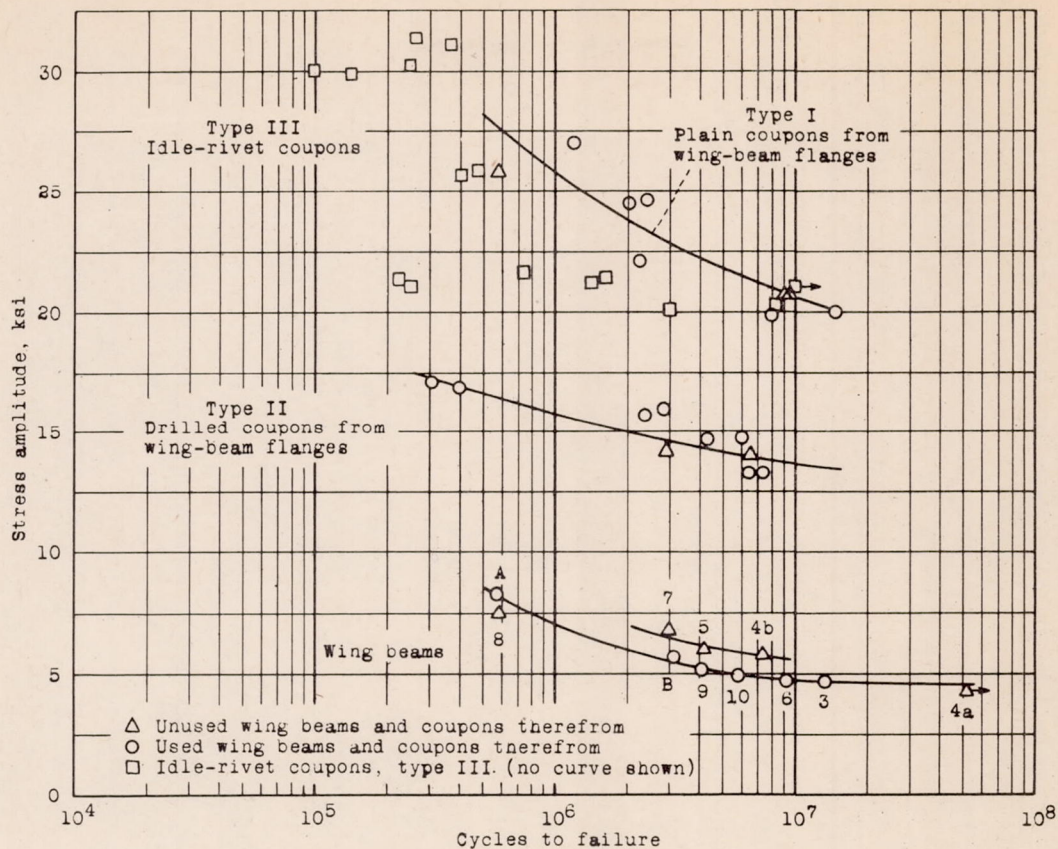
Static tensile and compressive properties of specimens machined from the flanges of some of the wing beams are given in table 2. Typical stress-strain curves are given in figure 8. S-N data for all specimens are given in figure 9; the fatigue stress concentration factor  $k_f$  which is defined as the ratio of the fatigue strength of coupon specimens of the material nominally free from stress raisers to the fatigue strength of the wing-beam specimens or drilled coupons is given in figure 10. The idle-rivet coupons showed so much scatter that  $k_f$  was not plotted. However, the results lie between those for the plain coupons and those for the drilled coupons. A description of the failure of each wing-beam specimen follows.

A smooth curve may be drawn through the plotted points in figure 9 with the exception of point 8; there is less scatter than usually is expected in fatigue results. The

The curve in figure 9 for the wing-beam specimens was drawn through the point A, although the fact that the web was not spliced placed this specimen in a different category from the others. It may be that point A should lie above a curve representing the fatigue strength of spliced specimens.

Figure 9.- S-N curves for wing beams and coupons.

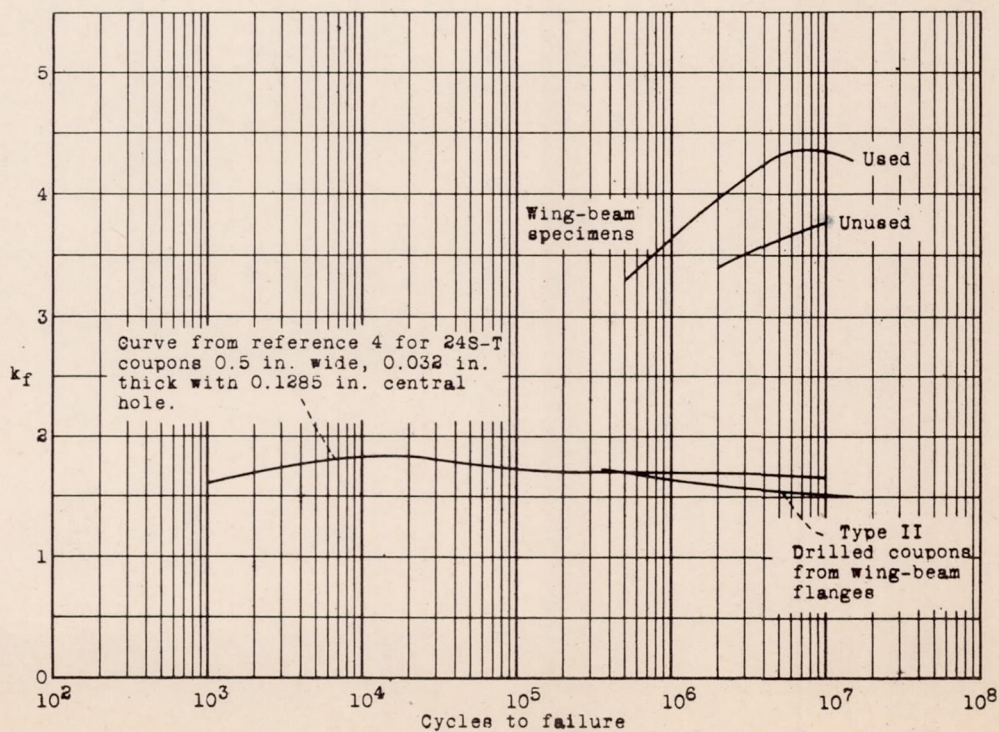
The results for both the plain and the drilled coupons are about the same as those previously obtained on 0.032-inch 24S-T sheet, which are reported in reference 4;  $k_f$  for these specimens is plotted in figure 10 for comparison.

Figure 10 shows that the fatigue stress concentration factor  $k_f$  for the wing beams is much higher than that for either the drilled or the riveted coupons; this indicates the presence of other, more damaging stress concentrations than that due to small rivet holes and idle rivets.

Figure 10.- Fatigue stress-concentration factors for wing-beam specimens and coupons.

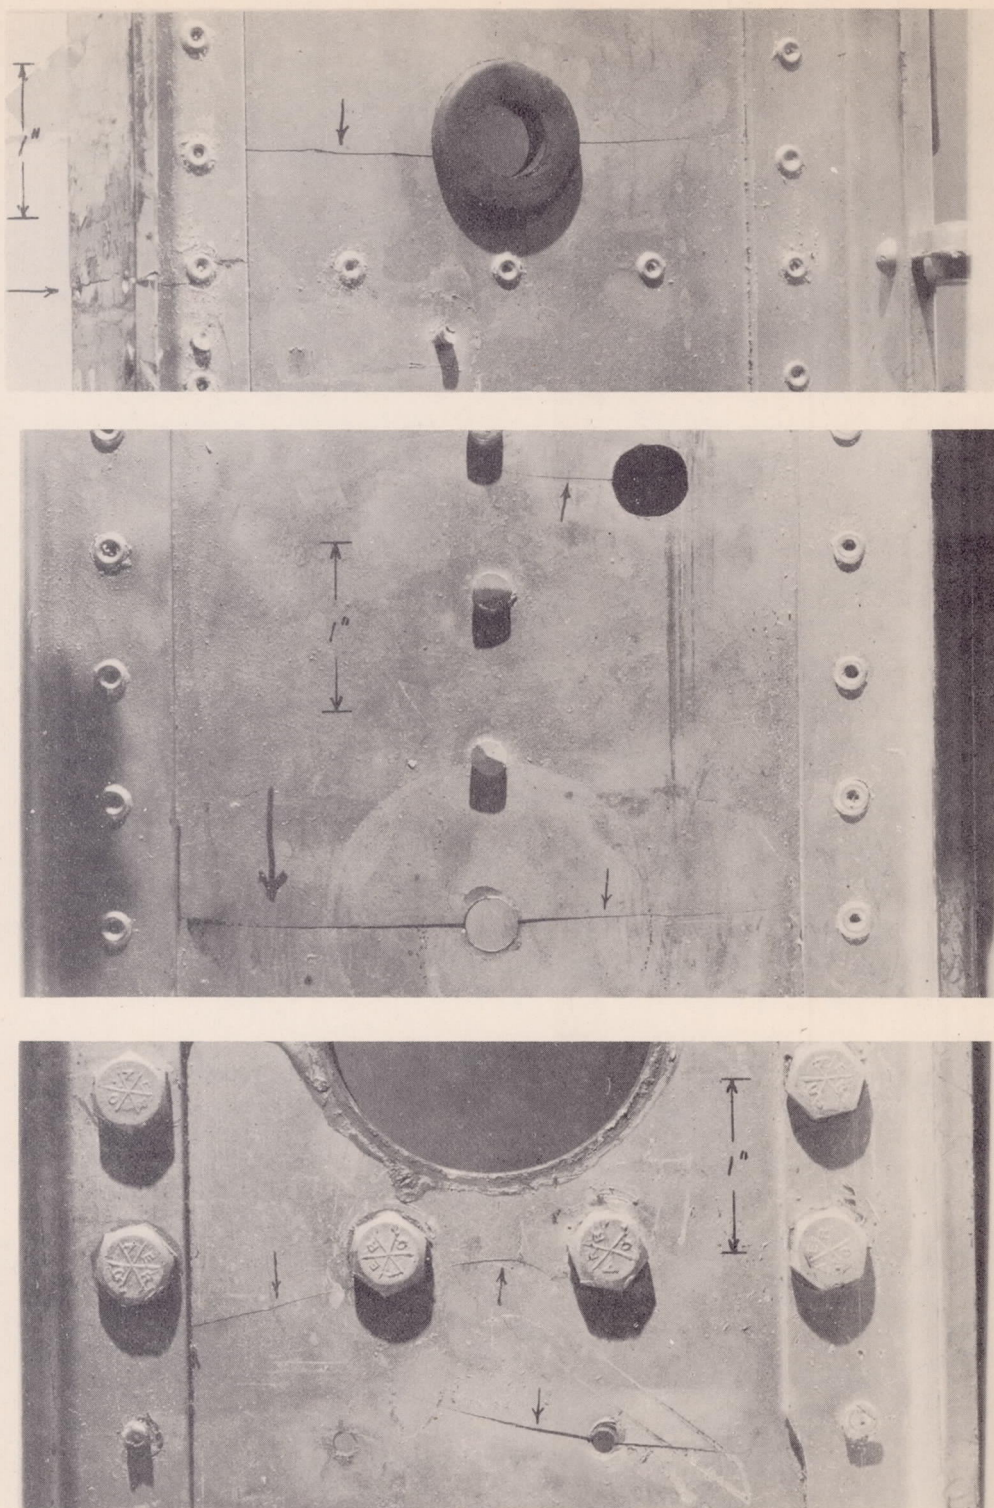
Specimen A, figure 11: Fracture passed through a 13/16-inch unfilled hole on the center line of web, and three filled rivet holes in the flange. Six other web cracks were found in the flange and are shown in reference 2, figures 22 and 23.

Specimen A, which was unspliced, failed at a 13/16-inch unfilled hole in the web;  $k_f$  was only slightly higher than the theoretical value of about 3, although still appreciably higher than the factor obtained on type-II specimens. It is believed that there is a possibility of size effect here. Such an effect has been observed in another investigation of the fatigue strength of strips containing holes, but these tests are as yet too incomplete to estimate this effect for specimen A.

Figure 11.- Fatigue cracks and fracture of specimen A. The principal failure which passes through three rivet holes in the flange and a  $\frac{13}{16}$ -inch grommeted hole in the web is shown at the top. The two holes in the flange were occupied by rivets fastening a portion of a rib; this was removed after failure to expose the fracture.

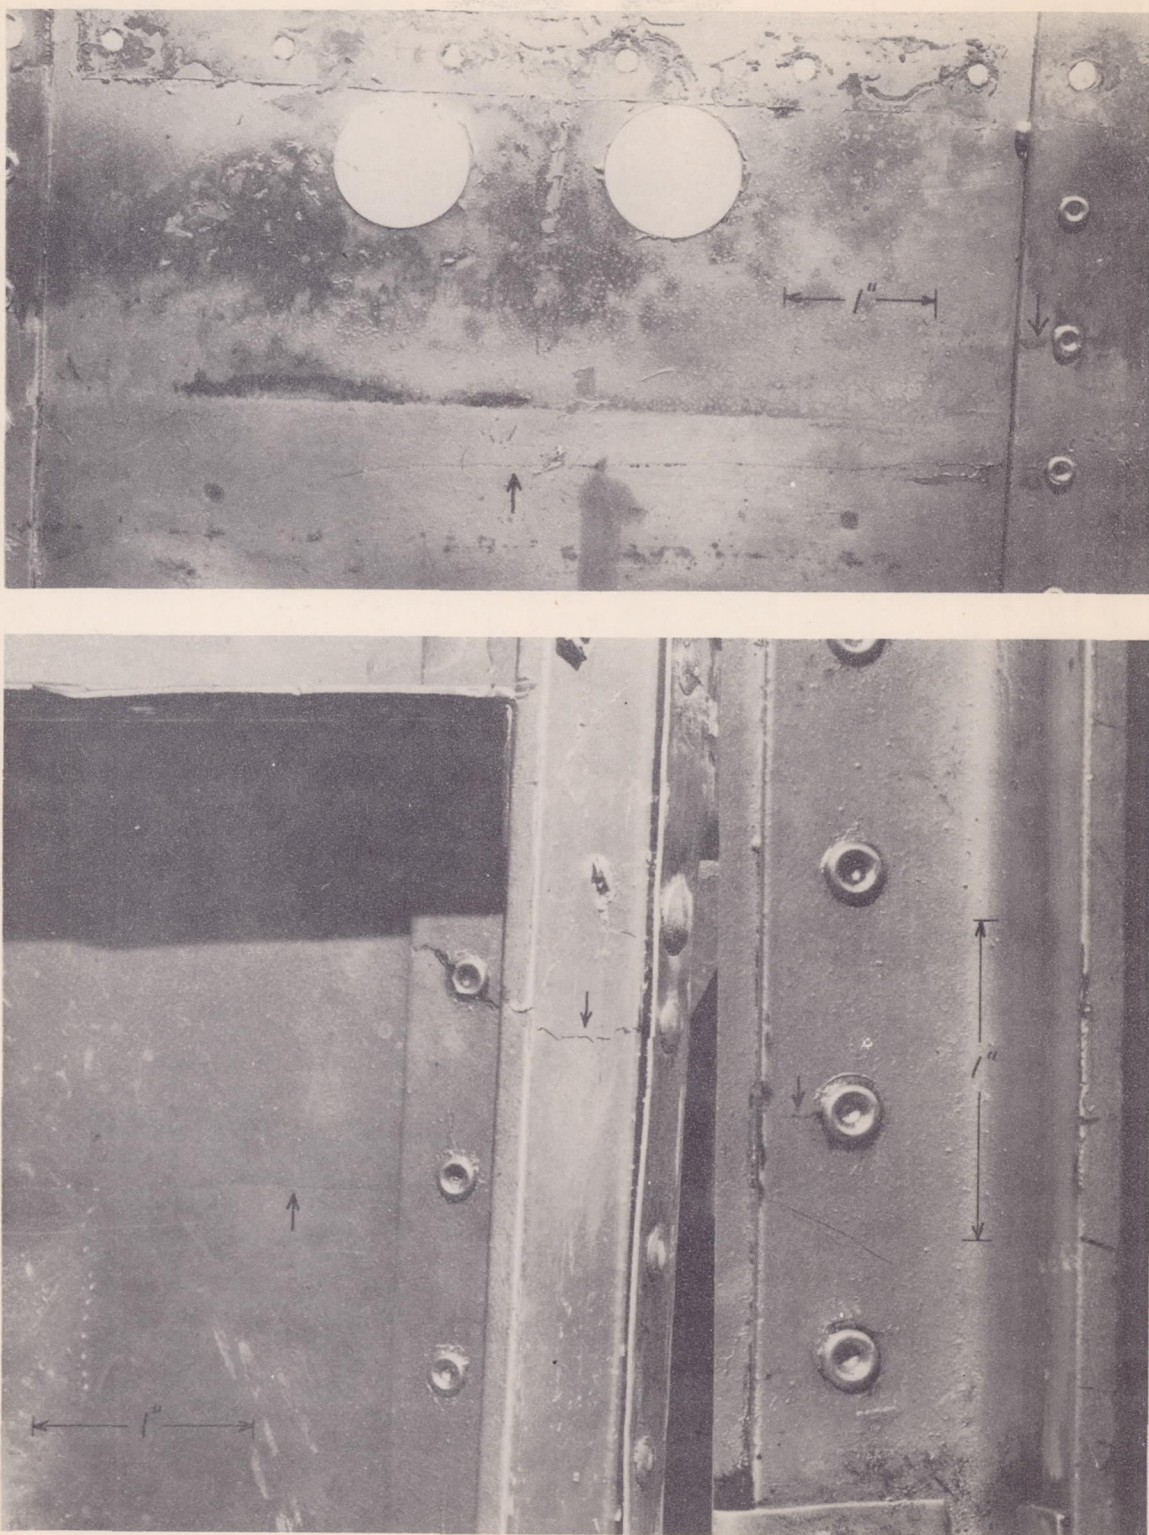
Specimen B, figure 12: The web and flange cracked at adjacent rivets; in addition, the web cracked at the terminal fixture. Both cracks were remote from the web splice. All flange cracks occurred in the same flange and all web cracks started at rivets passing through this flange.

Figure 12.- Failure of specimen B. The principal failure is shown at the lower left. The crack at the lower right is located at the web splice. A web crack at the terminal fixture is shown at the top

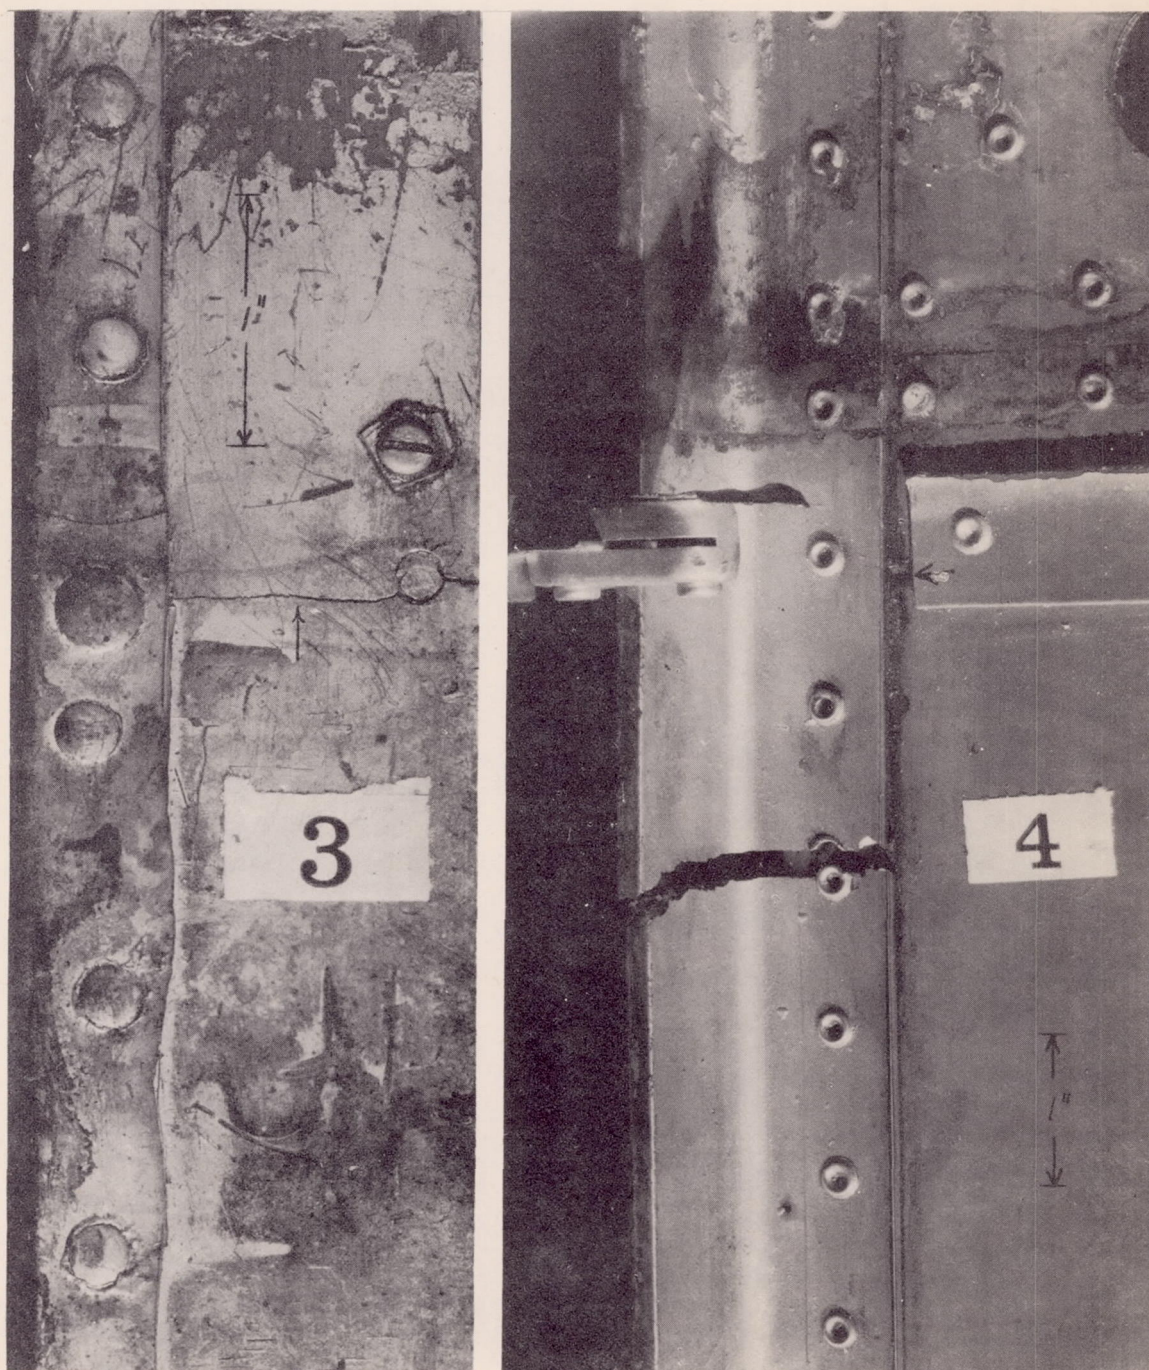
Specimen 3, figure 13: Failed at web splice. Cracks extended through rivet holes in web, butt strap, and flange. In addition, a crack originated at about 6,700,000 cycles in the web at the end of a doubler-plate reinforcement and at the time of the principal failure had penetrated into the stem of both flanges through rivet holes.

Specimen 4, figure 13: Failed at web splice. The fracture extended through the outer row of rivets at the splice and the stem rivet of the flange. A crack was first noticed at the stem rivet at about 6,800,000 cycles (specimen 4b).

Figure 13.- Fractures of specimens 3 and 4.

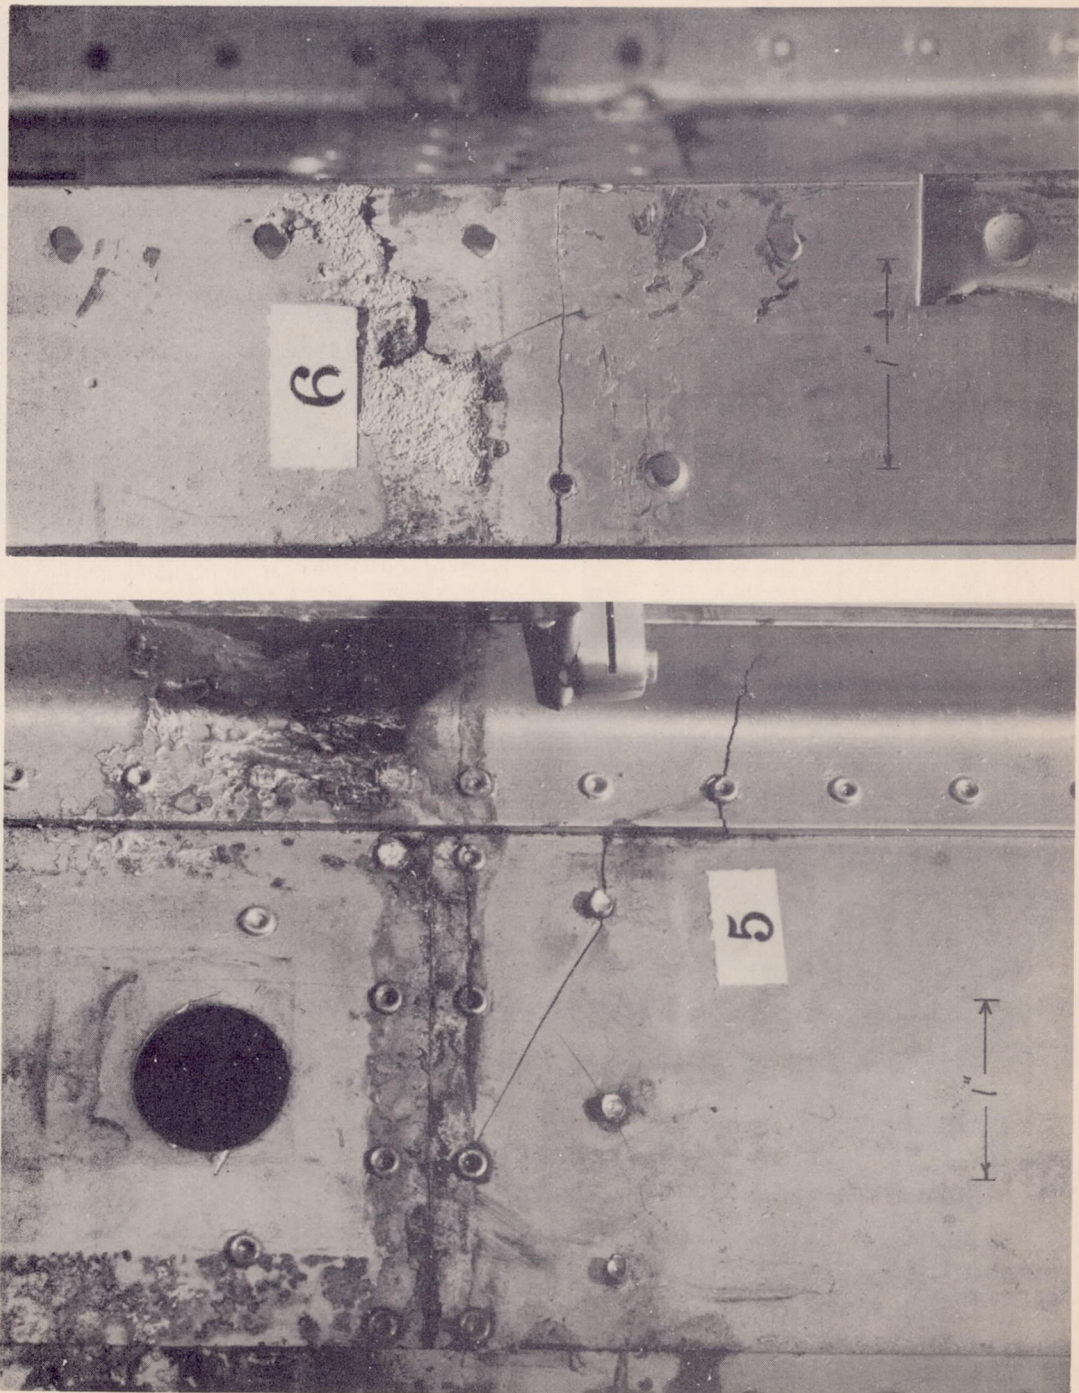
Specimen 5, figure 14: Failed through web splice and stem rivet of flange. Crack is believed to have started in web at about 2,000,000 cycles.

Specimen 6, figure 14: Flange failed opposite web splice. A crack was first noticed at about 10,000,000 cycles at a rivet hole in the outside of the flange and spread inward toward the stem.

Figure 14.- Fractures of specimens 5 and 6.

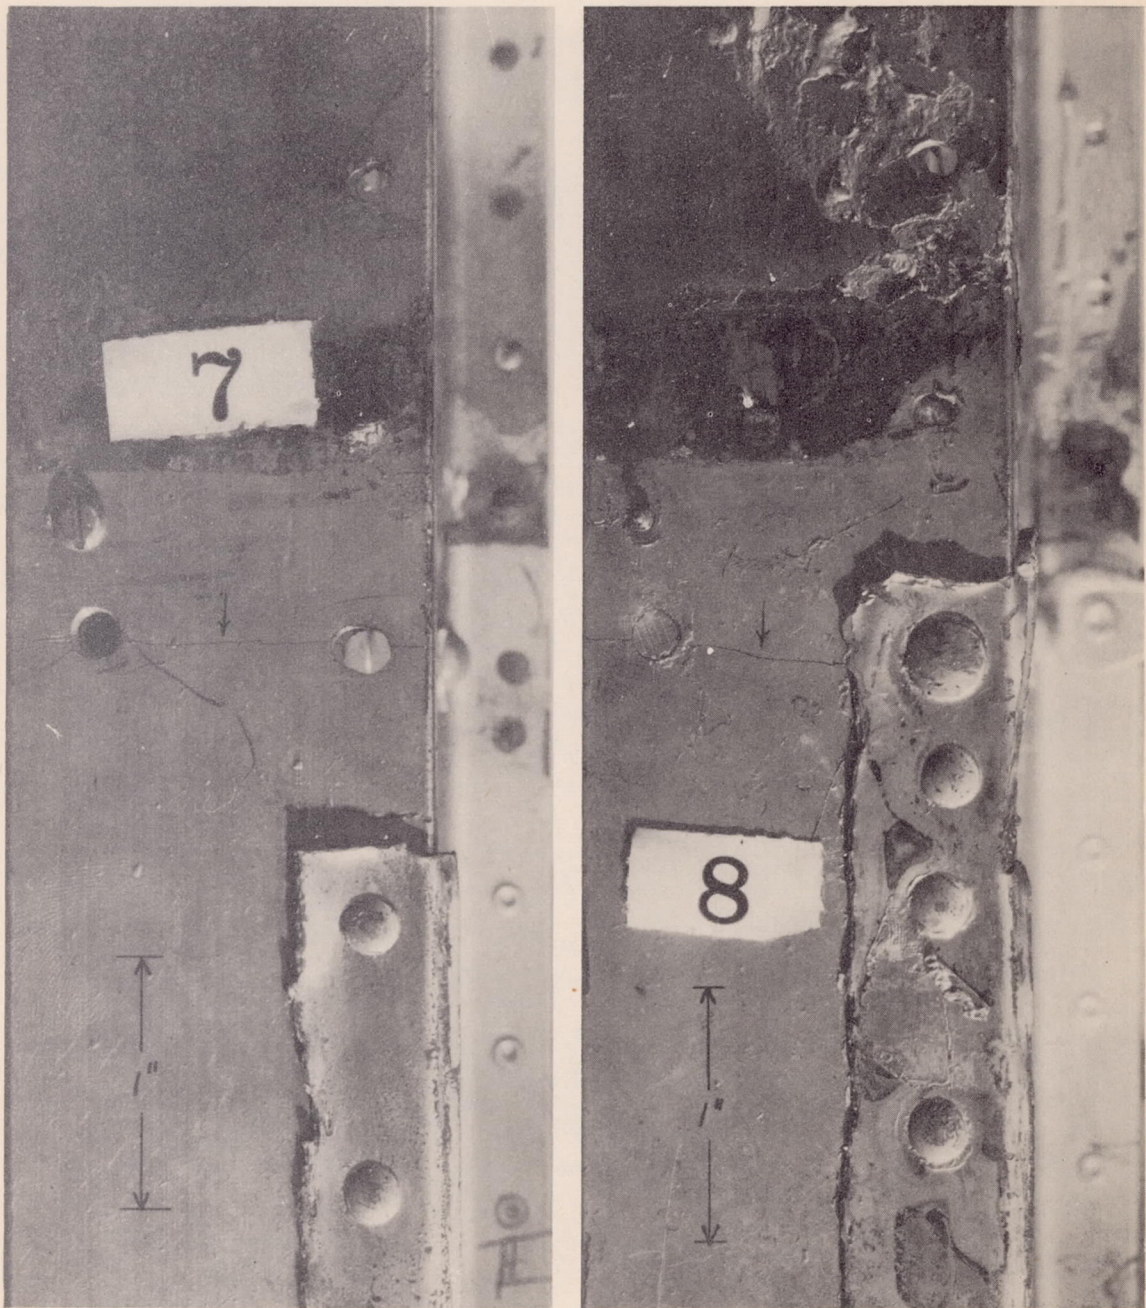
Considerable lateral vibration was encountered when testing specimen 8. After about 500,000 cycles the unsupported portions of the web began to vibrate loudly; shortly thereafter the whole system began to vibrate perpendicularly to the plane of the web. The double amplitude at the middle of the beam was about 2 inches. Attempts to snub out this undesired mode of vibration proved ineffective. It is probable that  $N$  for this specimen was lowered by this lateral vibration.

Specimen 7, figure 15: Failed opposite web splice in the same manner as specimen 6 except that the fracture passed through unfilled rivet holes. A crack was first noticed about 100,000 cycles before fracture.

Specimen 8, figure 15: Failed near web splice in the same manner as 6 and 7. Crack first noticed about 140,000 cycles before fracture.

Figure 15.- Fractures of specimens 7 and 8.

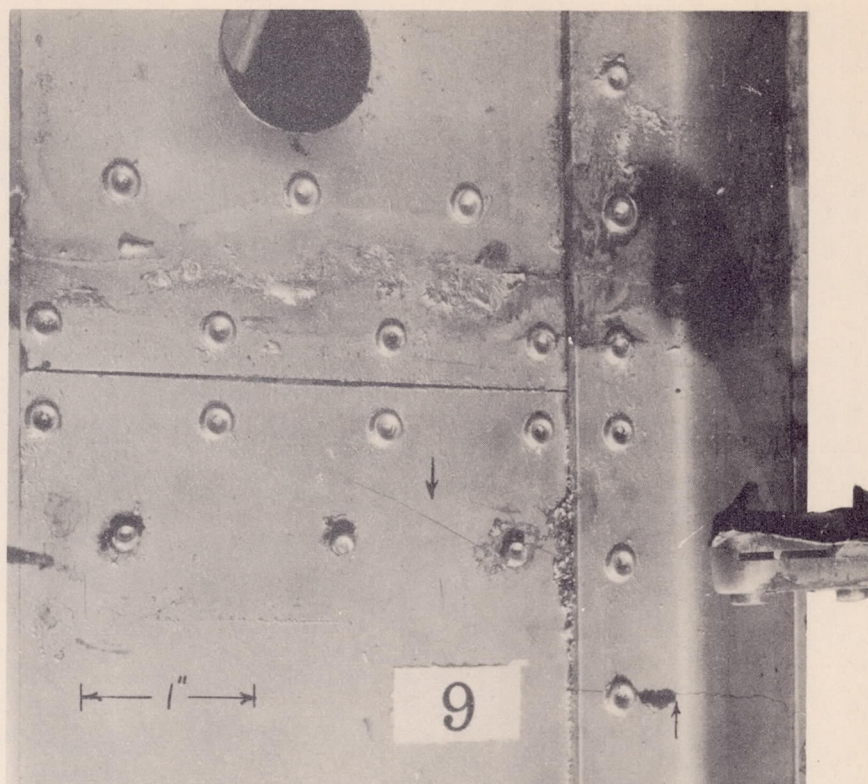
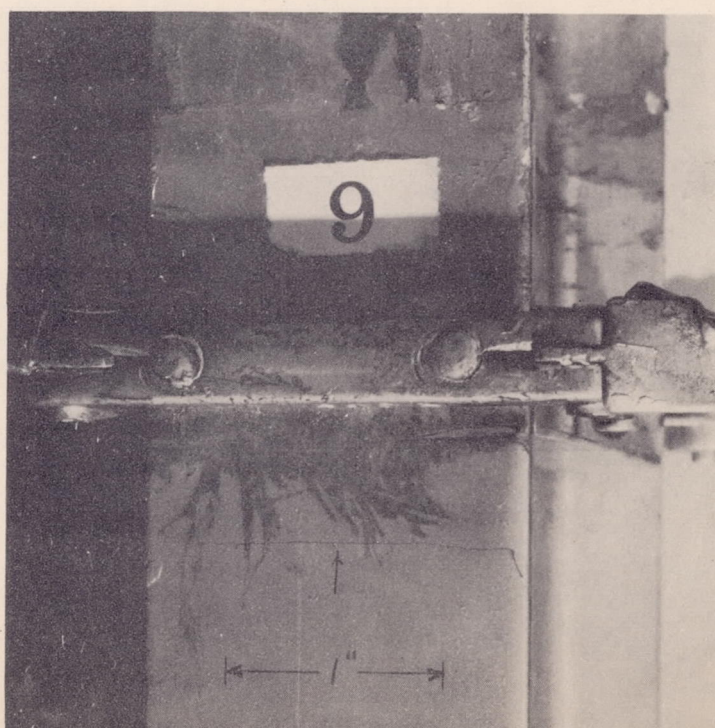
Specimen 9, figure 16: Failed at web splice in the same manner as specimen 5.

Figure 16.-  
Two views  
of the  
fracture  
of speci-  
men 9.

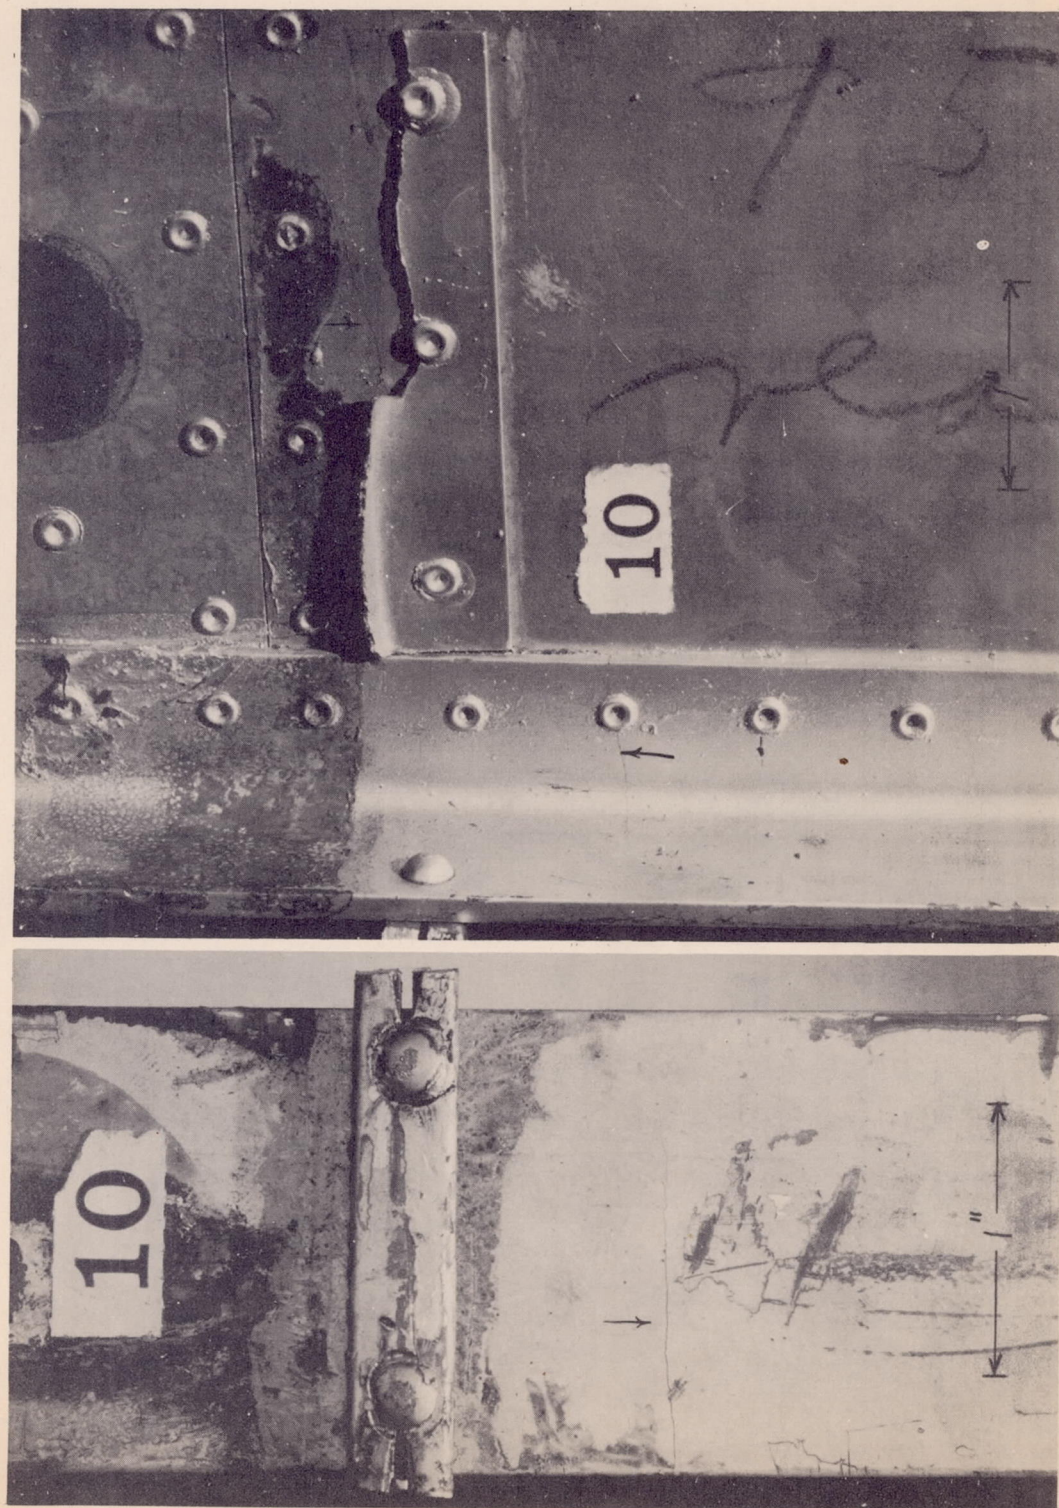
Specimen 10, figure 17: Web failed at splice and flange cracked through a stem rivet.

Figure 17.- Two views of the fracture of specimen 10.
